PHYSICAL NEEDS ASSESSMENT

Housing Authority of the City of Eureka
735 West Everding Street
Eureka, California 95503
Cheryl Churchill

Housing Authority of the City of Eureka
Various Addresses
Eureka, California 95503

August 5, 2020

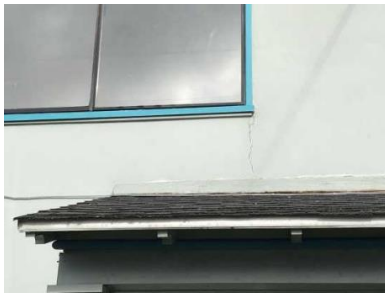
Exterior Wall in Poor condition.

Stucco, 1-2 Stories
531 to 708 W EVERDING STREET Exterior

Damage to the stucco around the building along settlement lines, windows, and doors. - AssetCALC ID: 1696076

Uniformat Code: B2011
Recommendation: **Replace in 2020**

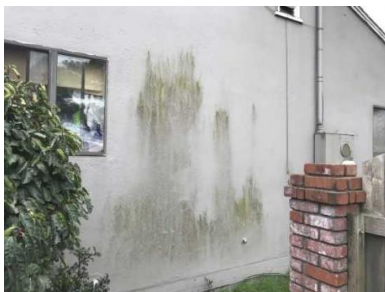
Exterior Wall in Poor condition.

Stucco, 1-2 Stories
3107 & 3111 PROSPECT AVE Exterior

Stucco and wood exteriors need to be painted. Moisture and texture of stucco has started to grow moss and mildew. - AssetCALC ID: 1696138

Uniformat Code: B2011
Recommendation: **Replace in 2020**

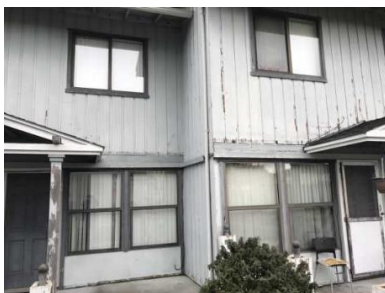
Exterior Wall in Poor condition.

Plywood
2320 SUMMER STREET Exterior

Paint is worn all over the building exposing the siding to the elements. - AssetCALC ID: 1696371

Uniformat Code: B2011
Recommendation: **Replace in 2020**

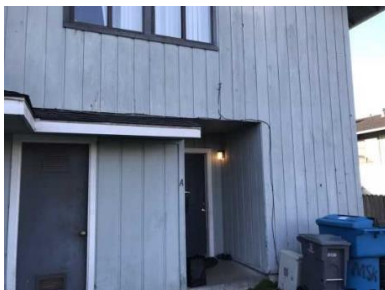
Exterior Wall in Poor condition.

Plywood Siding, 1-2 Stories
3213, 3221 & 3229 PROSPECT AVENUE
Exterior

Siding is damaged and showing signs of wear. Many areas of dry-rot, especially close to the ground. -
AssetCALC ID: 1696149

Uniformat Code: B2011
Recommendation: **Replace in 2020**

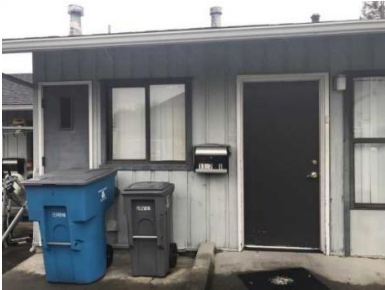
Exterior Wall in Poor condition.

Plywood
1109 to 1137 C STREET Exterior

Plywood at base of walls has deteriorated - AssetCALC ID: 1691467

Uniformat Code: B2011
Recommendation: **Replace in 2021**

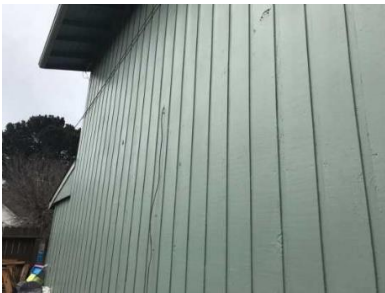
Exterior Wall in Poor condition.

Hardboard
2229 GARLAND STREET Exterior

Surface needs to be repainted. - AssetCALC ID: 1697466

Uniformat Code: B2011
Recommendation: **Replace w/Plywood in 2021**

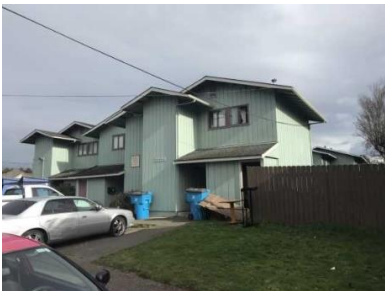
Roof in Poor condition.

Asphalt Shingle 20-Year
2229 GARLAND STREET Roof

Roof is very old and needs to be replaced. - AssetCALC ID: 1697451

Uniformat Code: B3011
Recommendation: **Replace in 2021**

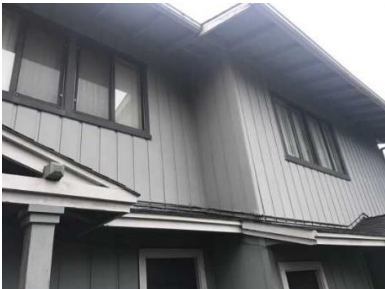
Exterior Wall in Poor condition.

Plywood Siding, 1-2 Stories
2315 & 2327 Union STREET Exterior

Exterior wall is in poor condition and needs to be replaced. - AssetCALC ID: 1695733

Uniformat Code: B2011
Recommendation: **Replace in 2021**

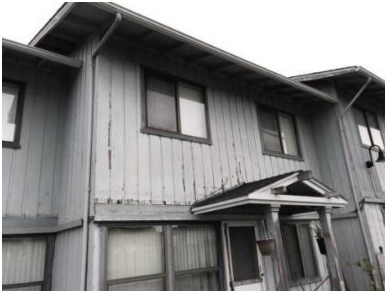
Exterior Wall in Poor condition.

Wood Clapboard Siding, 1-2 Stories
2320 SUMMER STREET Exterior

Paint is worn exposing the siding to elements. - AssetCALC ID: 1696377

Uniformat Code: B2011
Recommendation: **Replace in 2022**

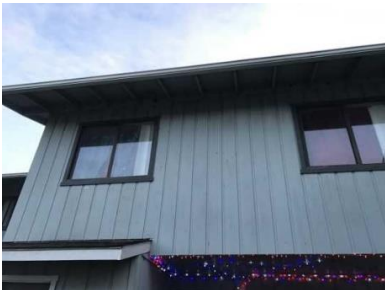
Exterior Wall in Poor condition.

Plywood Siding, 1-2 Stories
3213, 3221 & 3229 PROSPECT AVENUE
Exterior

The paint is wearing thin in places allowing the underlying wood siding to be exposed to elements. - AssetCALC ID: 1696197

Uniformat Code: B2011
Recommendation: **Prep & Paint in 2021**

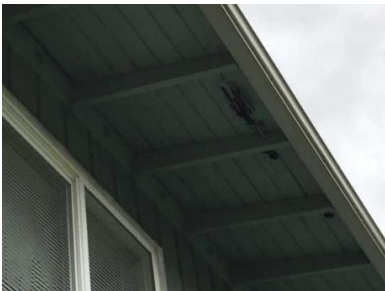
Exterior Wall in Poor condition.

Plywood Siding, 1-2 Stories
2218 & 2230 SPRING STREET Exterior

Siding and exterior fascia are dry-rotting. - AssetCALC ID: 1696214

Uniformat Code: B2011
Recommendation: **Replace in 2022**

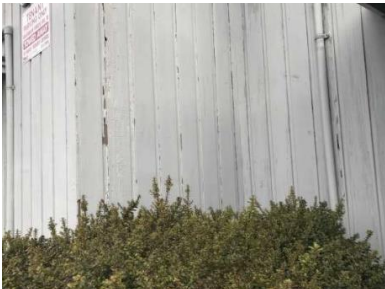
Exterior Wall in Poor condition.

Hardboard Siding
316 W. BUHNE STREET Exterior

Exterior wall surface is worn and needs to be replaced. - AssetCALC ID: 1695182

Uniformat Code: B2011
Recommendation: **Replace in 2022**

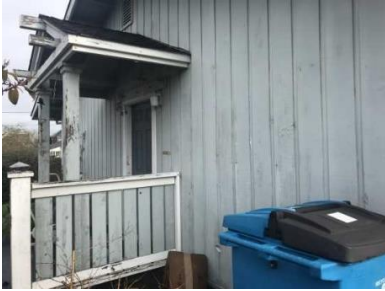
Exterior Wall in Poor condition.

Painted Surface, 1-2 Stories
216 & 224 CLARK STREET Exterior

Surface is worn needs repainting. - AssetCALC ID: 1693311

Uniformat Code: B2011
Recommendation: **Prep & Paint in 2021**

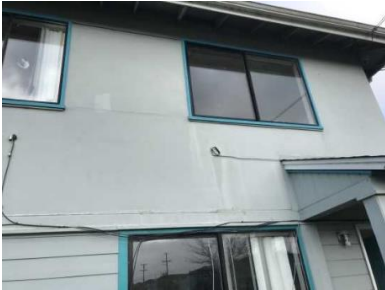
Exterior Wall in Poor condition.

Stucco, 1-2 Stories
531 to 708 W EVERDING STREET Exterior

Damage to stucco along settlement lines, around windows, and over doors. - AssetCALC ID: 1696032

Uniformat Code: B2011
Recommendation: **Replace in 2022**

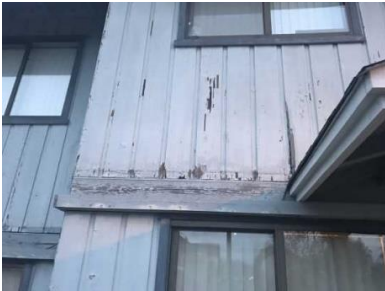
Exterior Wall in Poor condition.

Painted Surface, 1-2 Stories
2315 & 2327 Union STREET Exterior

Wall surface is worn needs to be repainted. - AssetCALC ID: 1695714

Uniformat Code: B2011
Recommendation: **Prep & Paint in 2022**

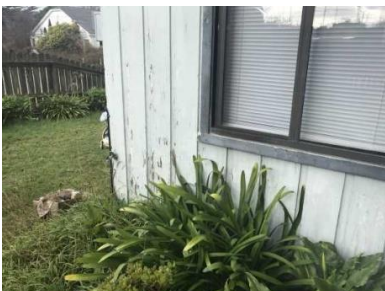
Exterior Wall in Poor condition.

Painted Surface, 1-2 Stories
1109 to 1137 C STREET Exterior

Paint is in poor condition and surface needs to be repainted. - AssetCALC ID: 1691418

Uniformat Code: B2011
Recommendation: **Prep & Paint in 2022**

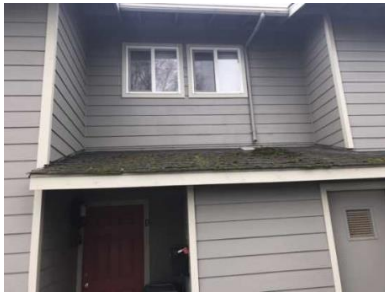
**Roof in Failed condition.**

Algae Damage
2523 ALBEE STREET Roof

Algae needs to be removed from the roof. - AssetCALC ID: 1695669

Uniformat Code: B3015
Recommendation: **Repair in 2020**

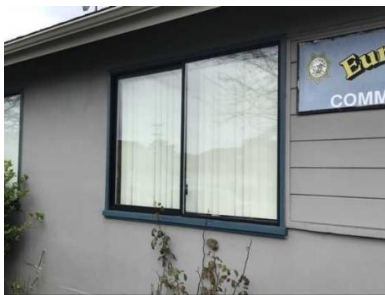
**Window in Poor condition.**

Aluminum
Police Operations Building exterior

The property reports problems with the windows, both thermally and leaking - AssetCALC ID: 1696543

Uniformat Code: B2021
Recommendation: **Replace in 2020**

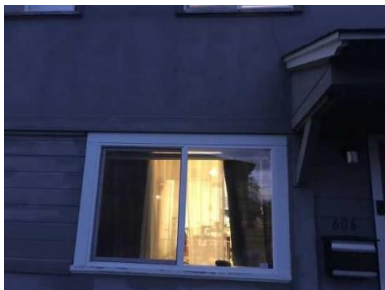
**Window in Poor condition.**

SF
605 to 664 BURRILL STREET Exterior

Windows does not insulate well and needs to be replaced. - AssetCALC ID: 1701056

Uniformat Code: B2021
Recommendation: **Replace in 2021**

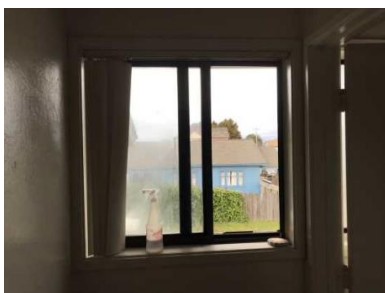
**Window in Poor condition.**

Aluminum
2218 & 2230 SPRING STREET Exterior

Windows do not completely seal leading to air infiltration, - AssetCALC ID: 1696233

Uniformat Code: B2021
Recommendation: **Replace in 2021**

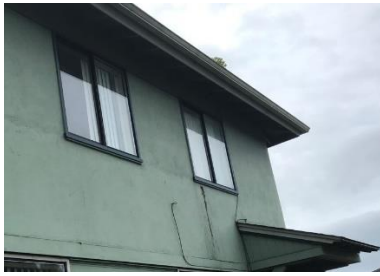
**Window in Poor condition.**

SF
621 to 729 W HARRIS STREET Exterior

Windows are not insulated well and need to be replaced. - AssetCALC ID: 1697784

Uniformat Code: B2021
Recommendation: **Replace in 2021**

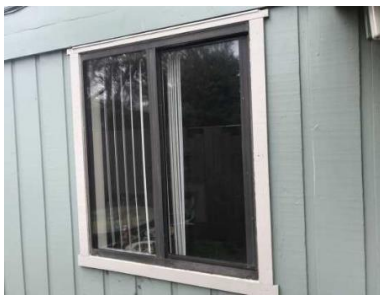
**Window in Poor condition.**

Aluminum
2229 GARLAND STREET Exterior

Windows are not insulated very well and need to be replaced. - AssetCALC ID: 1697450

Uniformat Code: B2021
Recommendation: **Replace in 2021**

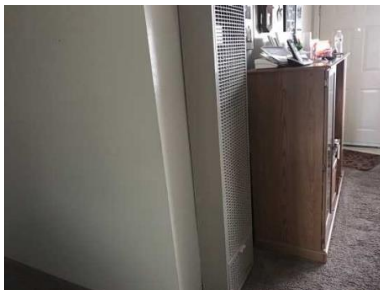
**Forced Air Furnace in Failed condition.**

Gas
3221 to 3254 HILER STREET Living Area

Furnace is very old and needs to be replaced. - AssetCALC ID: 1697701

Uniformat Code: D3021
Recommendation: **Install in 2020**

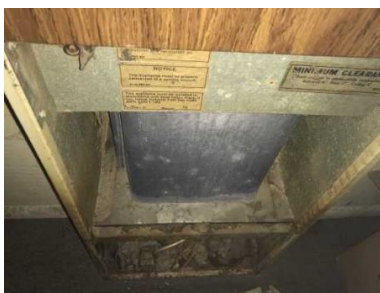
**Forced air Furnace in Poor condition.**

Gas
2315 & 2327 Union STREET Living Area

Furnace is very old and needs to be replaced. - AssetCALC ID: 1695739

Uniformat Code: D3021
Recommendation: **Install in 2020**
